# All-India Survey of Photovoltaic Module Reliability: 2018

National Centre for Photovoltaic Research  
and Education (NCPRE), IIT Bombay

National Institute of Solar Energy (NISE), Gurugram

March-May 2018

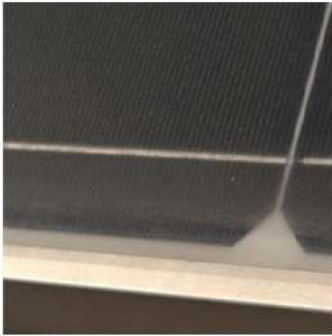
(a) Haziness in glass observed in old modules

Fig. 5.8. Glass degradation observed during the Survey

The front glass performs the role of protecting the solar cells from environmental factors like humidity and dust, while allowing the solar radiation to pass through to the cells. The deposition of dust and the use of hard water in cleaning the modules can lead to haziness in the glass (which can reduce the transmission of light to the cells). Also, improper handling can lead to scratches, chips and cracks (shattering) in the front glass, as shown in Fig. 5.8. Table 5.12 gives the statistics for the various degradation modes of front glass observed in the survey. Haziness is the most prevalent problem

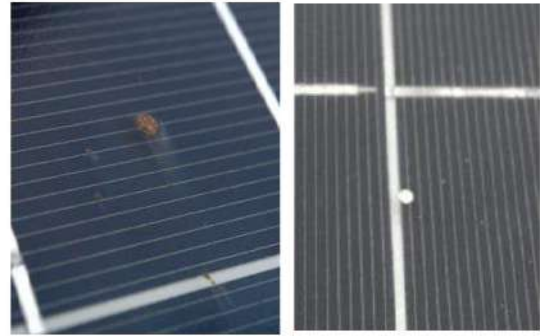
(b) Brown and white spots on front glass

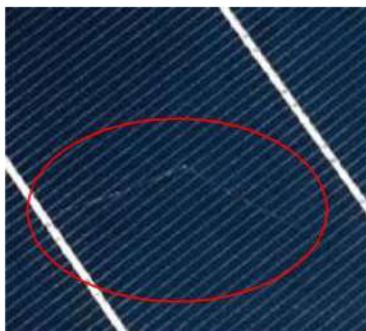
(c) Scratch on glass

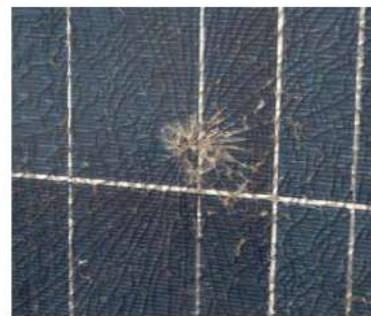
(d) Shattered glass

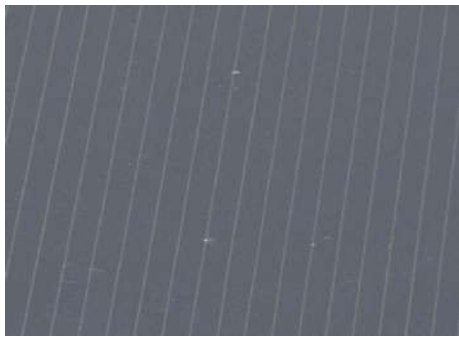
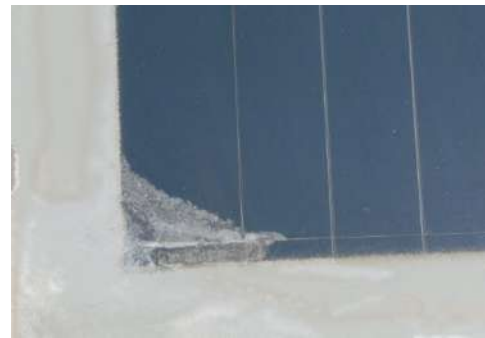
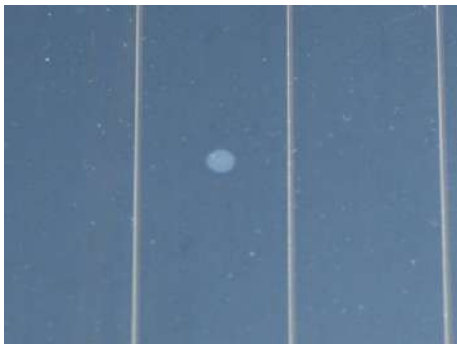
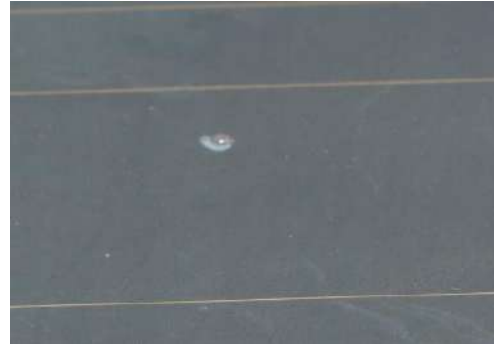
Fig. 5.15. Degradation in Thin Film modules (a) White spot in CdTe module, (b) Delamination of edge seal and inside cells (bar graph corrosion) in CdTe module, (c) haziness in CdTe module, (d) Delamination (Bubble) in CdTe modules

All of the modules were less than 10 years old, and were found only in the Hot climates (Hot & Dry, Warm & Humid, and Composite zones). Fig. 5.15 shows some of the most commonly seen degradation modes during our survey and Table 5.14 shows the statistics. White spots are commonly seen in thin film modules and are reported to be a visual indication of shunts, generated due to operation under partially shaded conditions [58, 59]. Delamination in the edge seal is also commonly seen, which can lead to TCO corrosion due to ingress of moisture into the module [57].

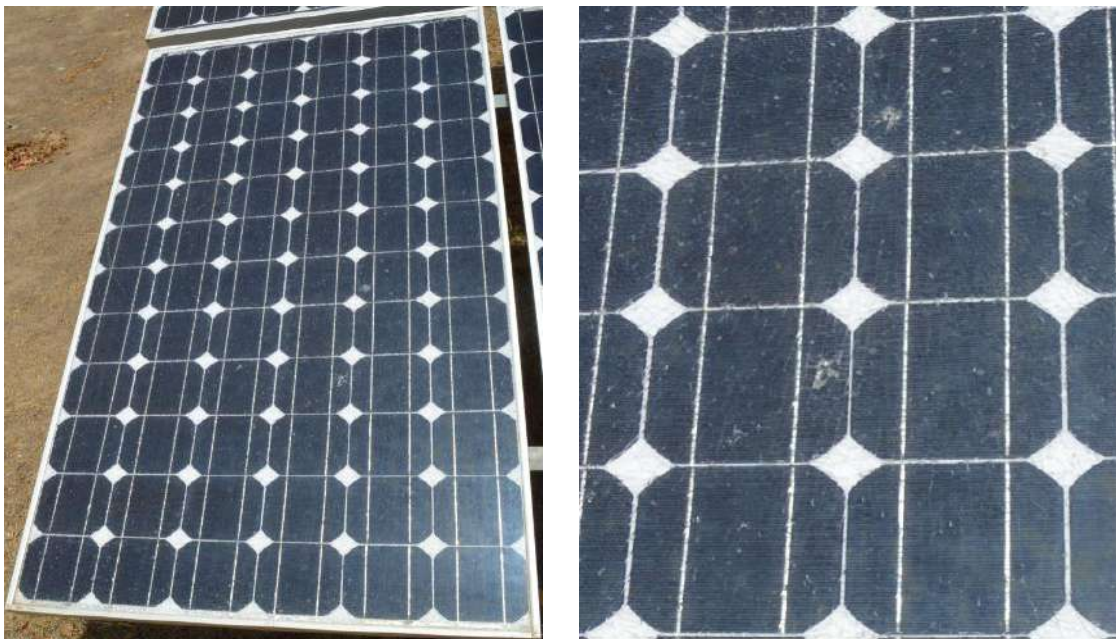
Fig. C.1. Visual Images of a Glass Broken PV Module

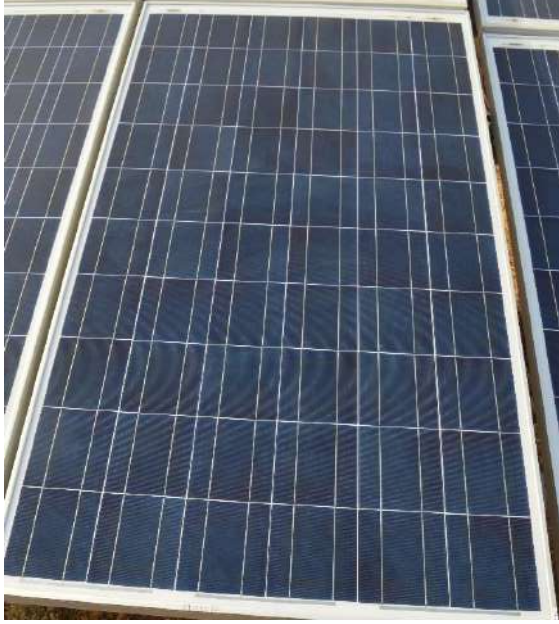
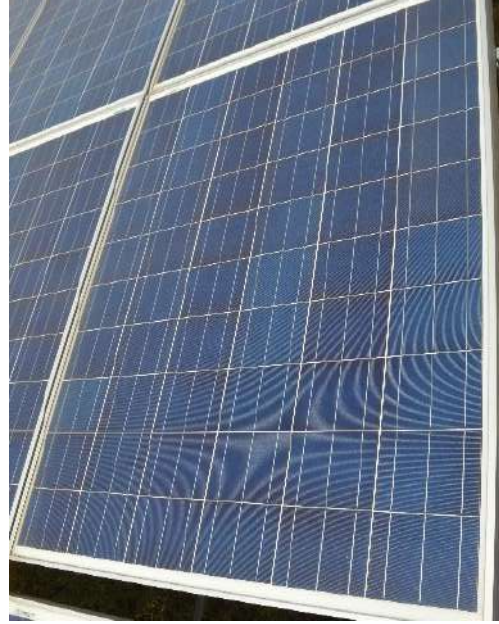
Fig. C.12. Visual image of outlier modules (a) Module in composite climate with no visual degradation but with linear  $P_{max}$  degradation of 7.35 %/year (b) Module in composite climate with no visual degradation but with linear  $P_{max}$  degradation of 7.25 %/year (c) Module in Hot and Dry climate with no visual degradation but with linear  $P_{max}$  degradation of 4.80 %/year (d) Module in Hot and Dry climate with no visual degradation but with linear  $P_{max}$  degradation of 4.50 %/year.

In the 2018 survey it is observed that one of the cause of modules (17 modules) to be outlier is PID. For these modules there is no visual defects observed. Fig C.12. (a), and C.12. (b) Shows the visual images of two PID affected PV modules. The respective EL images those PV modules are shown in section C.4.3, Fig. C.13. (a) and C.13. (b). The other 16 modules which lies in outlier category are
